**Flood Control Project Maintenance
Levee Inspections**

Maintenance Issue Types Only, Levee Inspection Report By Mile - Spring 2019

Reclamation District No. 1000 Natomas

Waterway	Bank	Unit Miles	Inspection Start/End	Inspector
Unit No. 01 Sacramento River	Left	18.28	04/16/2019 04/16/2019	Sterling York

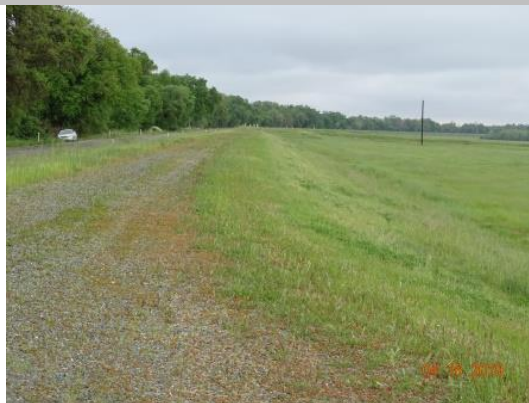
Photo 1 of 1 : SP_2019_RD1000_31_3_20190418_00050.jpg

LM Start	0.00	Rating **	A	Issue No.	3
LM End	12.32	Issue Type +	Ma	Location *	LS
Category	Earthen Levee			GPS Latitude/Longitude	
				Start	End
Item	Vegetation			38.780511 °	38.649646 °
				-121.603431 °	-121.570970 °
DWR ID	DWR_RD1000_01_s_2019_3				
Comment Code					
V1 : Control annual grass and weeds on the levee slopes and easements.					
Inspector Comment					
The annual vegetation is well maintained, Spring 2019.

View looking upstream landside at the well maintained annual vegetation, Spring 2019.

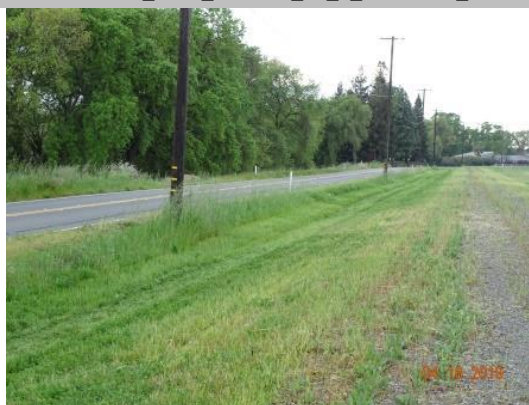
Photo 1 of 1 : SP_2019_RD1000_31_6_20190418_00051.jpg

LM Start	0.00	Rating **	A	Issue No.	6
LM End	12.32	Issue Type +	Ma	Location *	WS
Category	Earthen Levee			GPS Latitude/Longitude	
				Start	End
Item	Vegetation			38.780511 °	38.649646 °
				-121.603431 °	-121.570970 °
DWR ID	DWR_RD1000_01_s_2019_6				
Comment Code					
V1 : Control annual grass and weeds on the levee slopes and easements.					
Inspector Comment					
The annual vegetation is well maintained, Spring 2019.

View looking upstream waterside at the well maintained annual vegetation, Spring 2019.

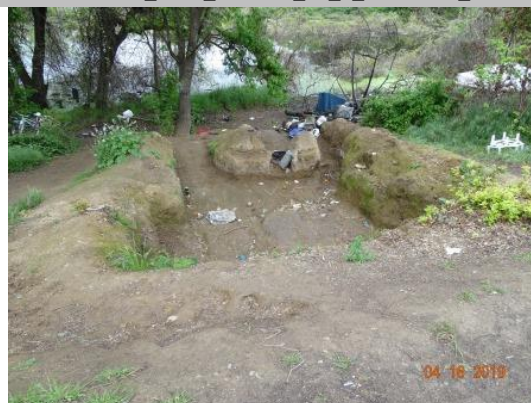
Photo 1 of 2 : SP_2019_RD1000_32_3_20190418_00001.jpg

LM Start	1.74	Rating **	U	Issue No.	3
LM End	1.74	Issue Type +	Ma	Location *	WS
Category	Earthen Levee			GPS Latitude/Longitude	
				Start	End
Item	Slope Stability			38.606874 °	38.606874 °
				-121.480394 °	-121.480394 °
DWR ID	DWR_RD1000_02_s _ 2019_3				
Comment Code					
S1 : Repair slope instability.					
Inspector Comment					
Repair the levee where the homeless have dug into the levee slope, Spring 2019.

View looking down the waterside slope where the homeless have dug into the levee slope, Spring 2019.

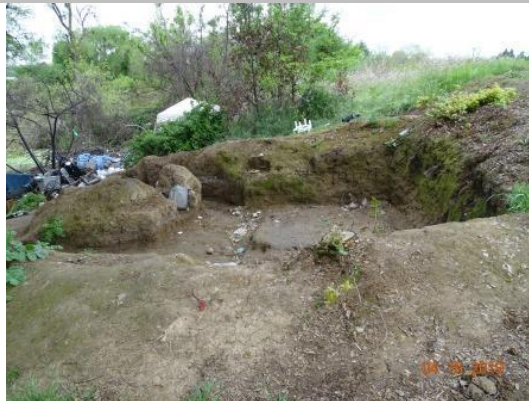
Photo 2 of 2 : SP_2019_RD1000_32_3_20190418_00002.jpg

LM Start	1.74	Rating **	U	Issue No.	3 (cont)	
LM End	1.74	Issue Type +	Ma	Location *	WS	
Category	Earthen Levee			GPS Latitude/Longitude		
				Start		End
Item	Slope Stability			38.606874 °		38.606874 °
				-121.480394 °		-121.480394 °
DWR ID	DWR_RD1000_02_s_2019_3					
Comment Code						
S1 : Repair slope instability.						
Inspector Comment						
Repair the levee where the homeless have dug into the levee slope, Spring 2019.

View looking upstream waterside slope where the homeless have dug into the levee slope, Spring 2019.

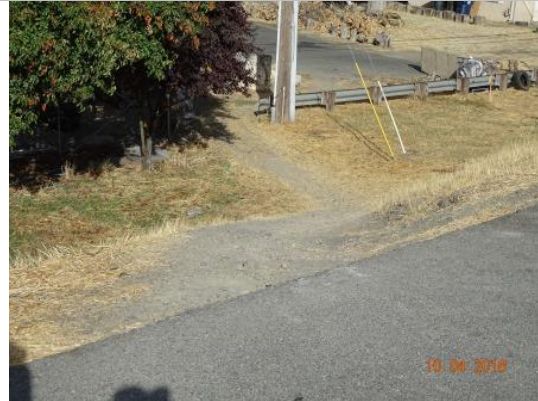
Photo 1 of 1 : SP_2019_RD1000_33_14_20190305_00011.jpg

LM Start	1.93	Rating **	A/W	Issue No.	14
LM End	1.93	Issue Type +	Ma	Location *	LS
Category	Earthen Levee			GPS Latitude/Longitude	
				Start	End
Item	Slope Stability			38.633110 °	38.633110 °
				-121.471868 °	-121.471868 °
DWR ID	DWR_RD1000_03_f _ 2018_14				
Comment Code					
S2 : Repair the levee slope damaged by foot traffic and prevent access where possible.					
Inspector Comment					
There is a foot path up the slope of the levee but it has not damaged the integrity of the levee enough to warrant an M rating. This path should be monitored and maintained to avoid a future maintenance issue.

View looking down the landside levee slope at a rut created by foot traffic, Fall 2018.

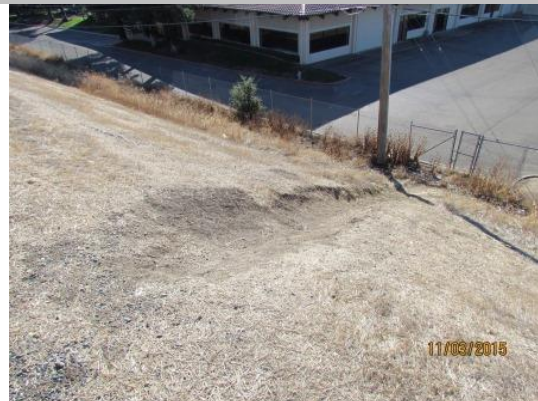
Photo 1 of 1 : SP_2019_RD1000_33_15_20190305_00012.jpg

LM Start	2.36	Rating **	M	Issue No.	15
LM End	2.36	Issue Type +	Ma	Location *	LS
Category	Earthen Levee			GPS Latitude/Longitude	
				Start	End
Item	Slope Stability			38.639326 °	38.639326 °
				-121.473107 °	-121.473107 °
DWR ID	DWR_RD1000_03_f_2015_15				
Comment Code					
S2 : Repair the levee slope damaged by foot traffic and prevent access where possible.					
Inspector Comment

View of the landside levee slope damaged by foot traffic.

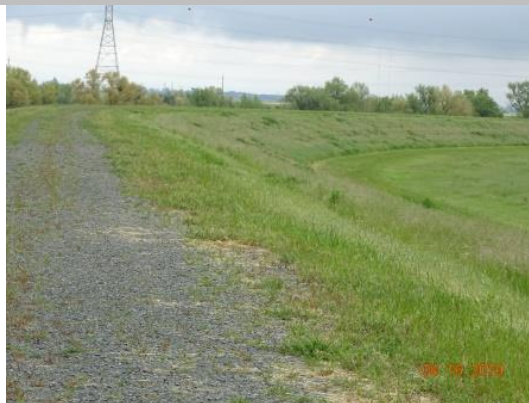
Photo 1 of 1 : SP_2019_RD1000_33_6_20190418_00015.jpg

LM Start	4.21	Rating **	M	Issue No.	6
LM End	16.85	Issue Type +	Ma	Location *	LS
Category	Earthen Levee			GPS Latitude/Longitude	
				Start	End
Item	Vegetation			38.665869 °	38.821482 °
				-121.477504 °	-121.542512 °
DWR ID	DWR_RD1000_03_s_2019_6				
Comment Code					
V1 : Control annual grass and weeds on the levee slopes and easements.					
Inspector Comment					
The annual vegetation needs to be maintained, Spring 2019.

View looking upstream landside at the annual vegetation, Spring 2019.

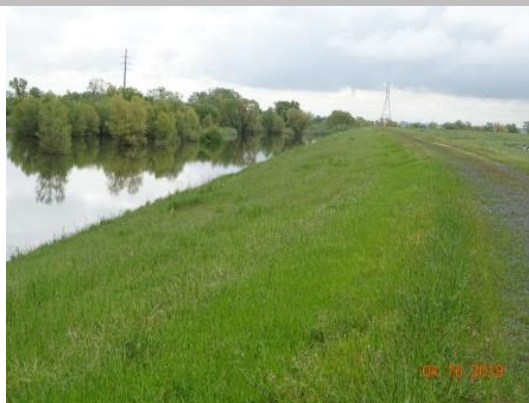
Photo 1 of 1 : SP_2019_RD1000_33_11_20190418_00016.jpg

LM Start	4.21	Rating **	M	Issue No.	11
LM End	16.85	Issue Type +	Ma	Location *	WS
Category	Earthen Levee			GPS Latitude/Longitude	
				Start	End
Item	Vegetation			38.665869 °	38.821482 °
				-121.477504 °	-121.542512 °
DWR ID	DWR_RD1000_03_s_2019_11				
Comment Code					
V1 : Control annual grass and weeds on the levee slopes and easements.					
Inspector Comment					
The annual vegetation needs to be maintained, Spring 2019.

View looking upstream waterside at the annual vegetation, Spring 2019.

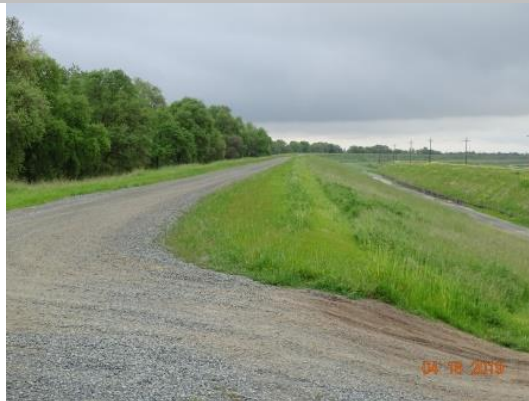
Photo 1 of 1 : SP_2019_RD1000_34_13_20190418_00001.jpg

LM Start	0.22	Rating **	M	Issue No.	13
LM End	4.24	Issue Type +	Ma	Location *	LS
Category	Earthen Levee			GPS Latitude/Longitude	
				Start	End
Item	Vegetation			38.818690 °	38.781322 °
				-121.546997 °	-121.603445 °
DWR ID	DWR_RD1000_04_s_2019_13				
Comment Code					
V1 : Control annual grass and weeds on the levee slopes and easements.					
Inspector Comment					
The annual vegetation needs to be maintained, Spring 2019.

View looking upstream landside at the annual vegetation, Spring 2019.

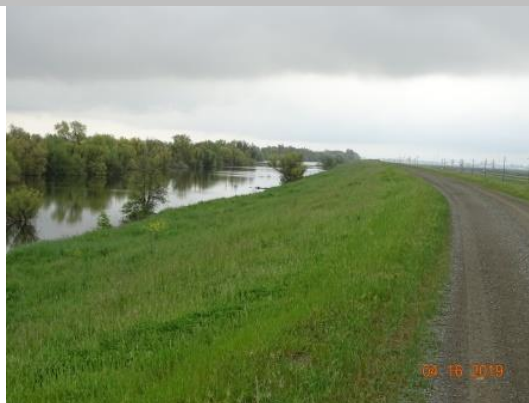
Photo 1 of 1 : SP_2019_RD1000_34_14_20190418_00002.jpg

LM Start	0.22	Rating **	M	Issue No.	14
LM End	4.24	Issue Type +	Ma	Location *	WS
Category	Earthen Levee			GPS Latitude/Longitude	
				Start	End
Item	Vegetation			38.818690 °	38.781322 °
				-121.546997 °	-121.603445 °
DWR ID	DWR_RD1000_04_s_2019_14				
Comment Code					
V1 : Control annual grass and weeds on the levee slopes and easements.					
Inspector Comment					
The annual vegetation needs to be maintained, Spring 2019.

View looking upstream waterside at the annual vegetation, Spring 2019.
